JAMES CROSS & Associates, Certified Marine Surveyors

Re: 1976 Cape Dory 25

This letter reports the results of a survey of the above vessel which was inspected on the 21st of April 2013, at Wayfarers Cove Marina, Minnesott Beach, North Carolina, while hauled. You requested the inspection to establish it's condition and value as an extensive refit due to age and weathering, has just been completed.

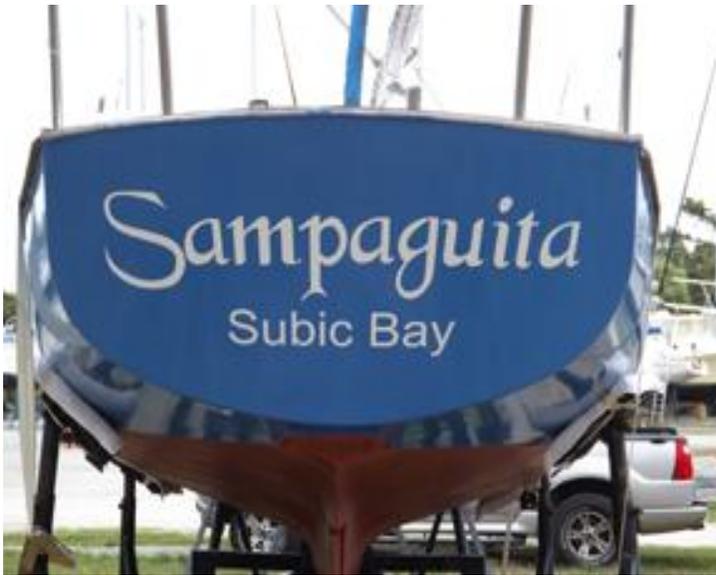
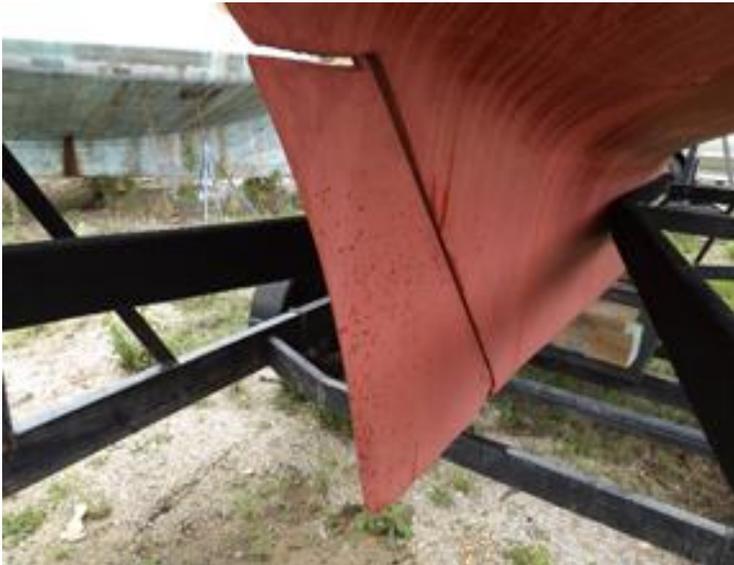
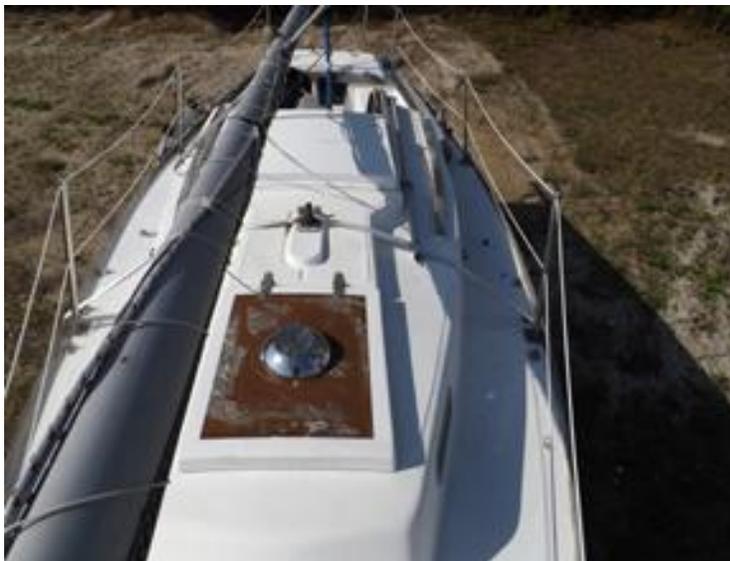
Hull and Structure

This boat sat un-used and on the hard for 15 years, for several years the companioway was left open and the interior was damaged. The hull was found to be solid, but the deck core had been compromised. The deck was repaired by notable boat rescue man, Mike McGlynn. Mike also gutted the interior and rebuilt most of it. It is still a work in progress.

The hull is a typical polyester laminate, reinforced with fiberglass matt and woven roving. The hull is sturdy and there is no evidence of damage or repairs. The hull between the waterline and gunwale is in Bristol condition with a several coats of Interlux, Largo Blue finish applied.

The hull, below the waterline was also sounded with a plastic mallet and no soft spots or delamination was noted. There are no blisters present. The keel is sound and properly mated to the hull.

The rudder attachment hardware is in excellent condition. Excess play was not noted at the rudder. Excess play was not noted at the tiller attachment. The bottom has been coated with Interlux, ablative anti fouling paint.

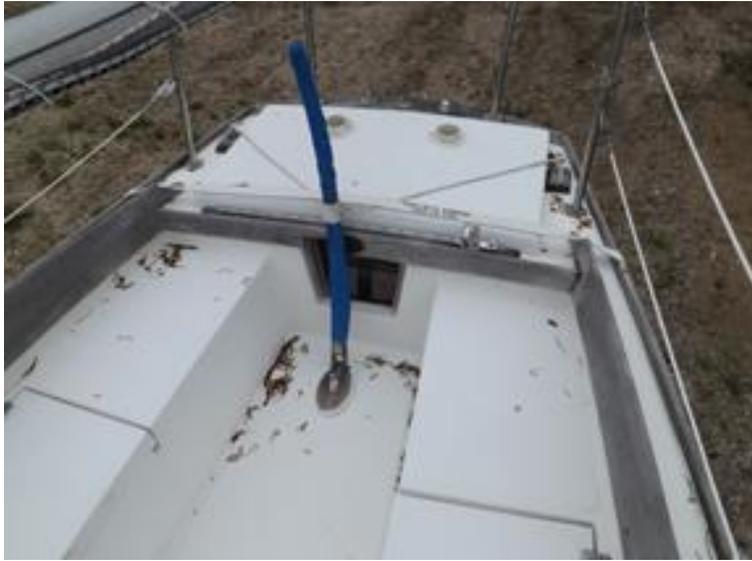
The toe rail is teak, and is solid and in fair condition. There is backing under all attachments through the deck that should be supported - cleats, etc. The main sheet traveler is located in the cockpit area and is in good condition and properly backed and secure. All vents and hatches are tight to the weather. A new exhaust vent has been recently added to the forward hatch.

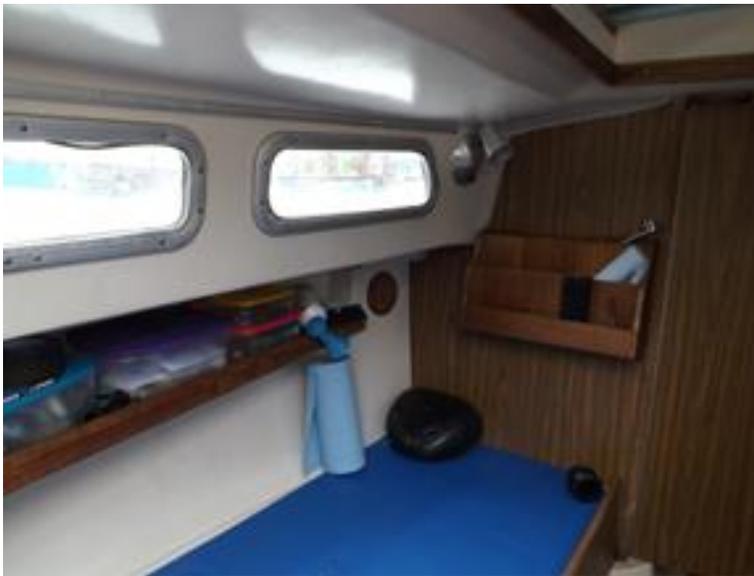
Interior

The cabin is small, but clean. The head is the original Wilcox Crittenden and in very good condition. There is adequate locker space in the main cabin. Ports, vents, and hatches are secure and weather tight. The galley consists of a one burner propane stove. The water system is still in work. There is rode storage at the forepeak. The icebox is clean and in overall excellent condition. This boat was designed with berthing for four adults. There is presently berthing for two, due to forward v-berth being rebuilt. The forward 30 gallon water tank cover is being rebuilt also.

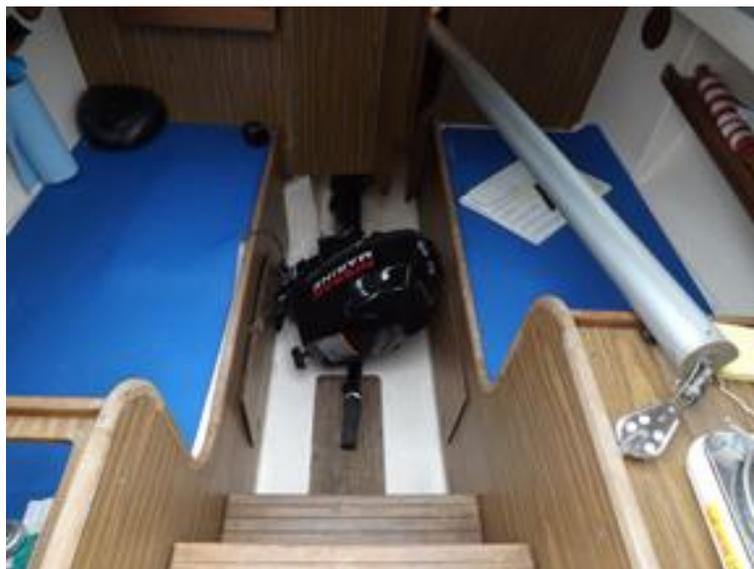
Bilge

The large bilge is clean. Access to the bilge is in the main cabin. There is a manual bilge pump installed in the starboard cockpit locker. The bilge is operated from the cockpit only.
