Mike McGlynn, Marine Surveyor

Re: 1988 28' Pearson Sloop "First Luff"

This letter reports the results of a survey of the above vessel which was inspected while hauled, on the 4th of May, 2013, at Wayfarers Cove Marina, Minnesott Beach, North Carolina. This inspection is to determine the present condition and value of your vessel.

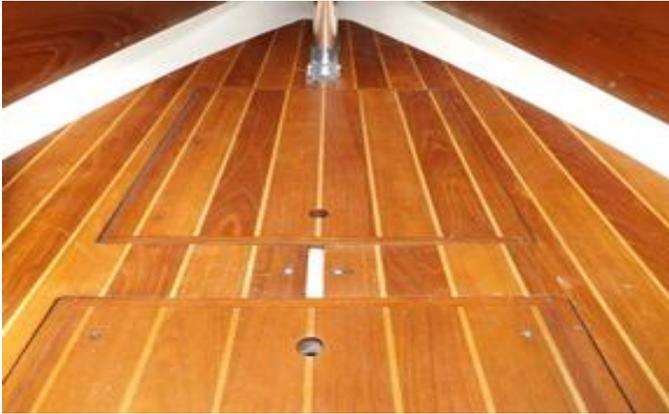
Image One

Image One, Clean sturdy teak and holly sole.

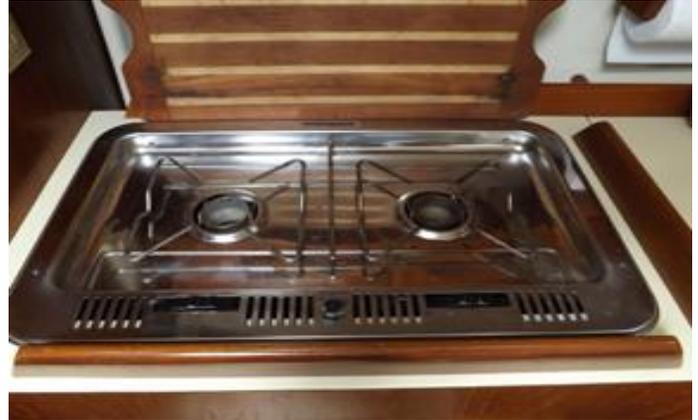
Image Two

Image Two, Origo alcohol stove..

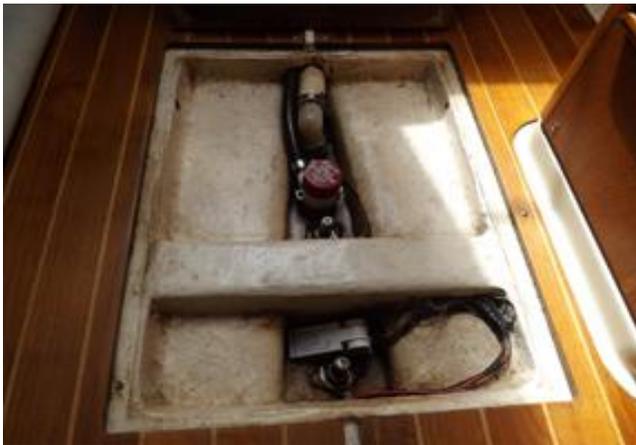
Image Three

Image Three, Keel bolts, bilge pump, and float switch.

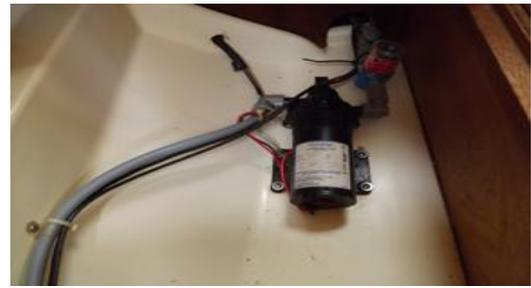
Image Four

Image Four, Potable water pump & filter..

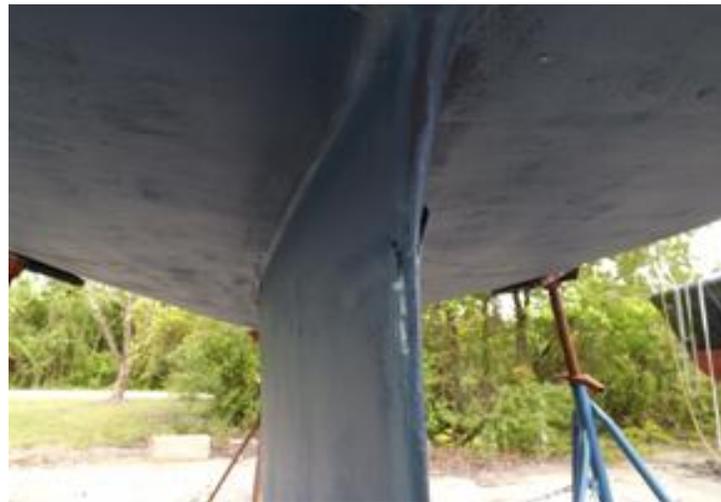
Image Five

Keel delam: What kind & size, how deep. This keel should be solid lead!! Need a better photo.

Image Five, Evidence of delamination on keel, this is an area of concern.

This vessel is in very good to excellent condition. The current repair work being performed on the hull deck joint and toe rail, is being carried out in a professional manner. Further inspection of the delamination on the keel must be undertaken.
