Mike McGlynn, Marine Surveyor

Re: 2007 Seaway Fisherman (Leyte Luck III)

This letter reports the results of a survey of the above vessel which was inspected while hauled, and without a sea trial on the 22nd of September, 2011, at the Cherry Point base marina in Cherry Point, North Carolina. You requested the inspection to establish its condition and value.

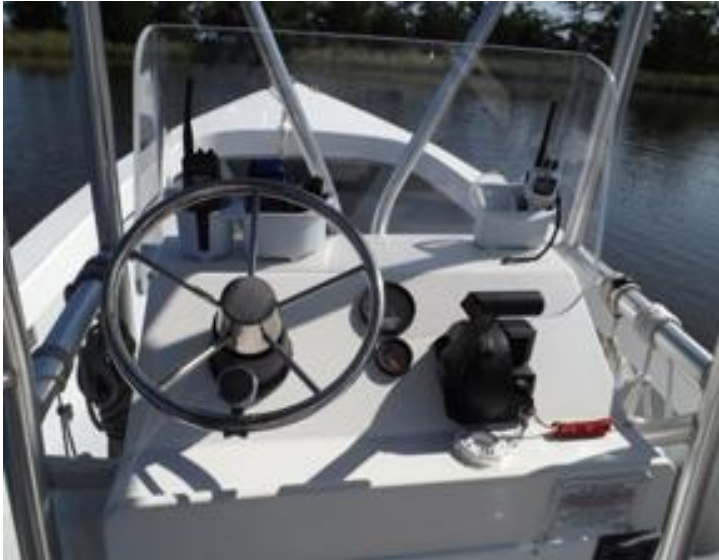
The hull is a polyester laminate reinforced with fiberglass mat and woven roving in a modified deep V configuration. The gel coat is white, and in very good clean condition. A new coat of wax is needed.

The forward deck is clean and in good condition. There are no bow rails, solid line leads and a cleat are mounted on the bow. The deck is glassed to the hull with fiberglass mat and chop. The joint is very solid and has an aluminum and rubber rub rail attached by stainless steel screws along the length of the hull deck joint.

There is no inner liner in this boat. The deck is solid glass and in pristine condition. It is obvious that this vessel has had no abuse. There is no bilge pump and the bilge is not easily accessible. The topsides are white, and in good condition, free of mars and scratches. All deck hardware are properly mounted and secured. The windshield is clear and not scratched.

The steering system is in very good condition, smooth with no binding. There is no compass mounted. The Tee Top is securely mounted and constructed of aluminum. The navigation lights comply with CFR regulations. An adequately sized Danforth type anchor and adequate rode is provided in a locker at the bow. A spare anchor and rode are on board.

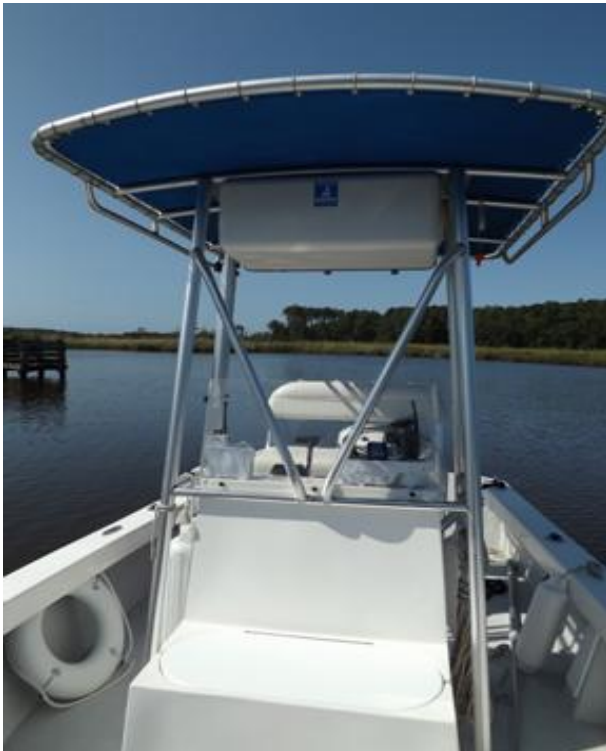
The cockpit is equipped with a Tee Top. The supporting structure and top are in good condition. The structure is properly backed at the attachment points. The stainless steel wheel, gauges and controls are in good shape. The cockpit area is clean and the finish is in unusually good condition. The vinyl upholstery on the helm seat, is also in good condition. The control panel and switches appear in lightly used condition. The fuel fill is properly installed and marked. There is storage within the

center console. Access to the battery is through the access hatch on the center console.

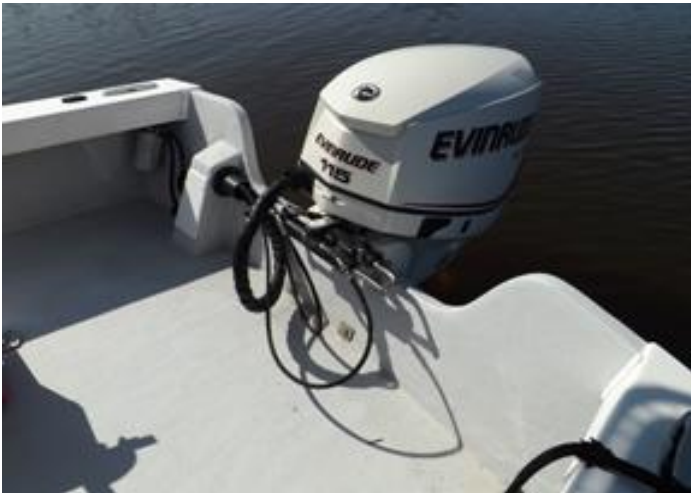
Propulsion is by a single raw water cooled Evinrude ETEC 115 HP outboard engine. The engine was started and ran with no hesitation. All zincs are in good condition. Visual inspection of the engine, oil, filters, and related connections show no signs of misuse. Inspection of the lower unit and propeller indicate no grounding of any consequence. There is no bilge blower installed on this vessel, nor is there a requirement for such. There is no bilge pump, but there should be one installed. The 40 gallon aluminum fuel tank cannot be inspected. It is properly secured and grounded, as are the related fills and vents. There is no fuel shut-off

valve on the feed line.

Electric/hydraulic engine tilt/trim are working properly. The engine trim switch is working properly. The engine shows very little use and is very clean and well maintained. The overall appearance of the engine, mounts, and control systems, is very good.

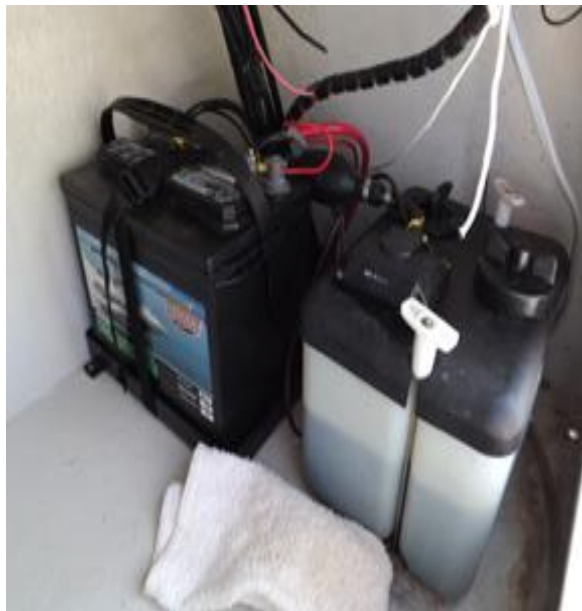
The gear compartment forward of the center console is clean, odor free, and provides ample storage space for all required safety equipment and a spare anchor and rode. There is a single battery in the center console compartment, there is no battery switch. The battery is new and properly installed and secured. The battery connections are appropriate as are the cables. The electrical wiring and terminals observed throughout the vessel are in very good condition. The throttle and gear linkages are in good order and work smoothly.

Recommendations: Install a VHF radio, a depth sounder, and a GPS unit. A second battery with a battery switch should also be considered. For extended cruising, a bilge pump should be installed.
